# Final Technical Report -

## *Arcadia Marsh / Bowens Creek Restoration and Fish Passage*

Little River Band of Ottawa Indians

Final Technical Report - 2013

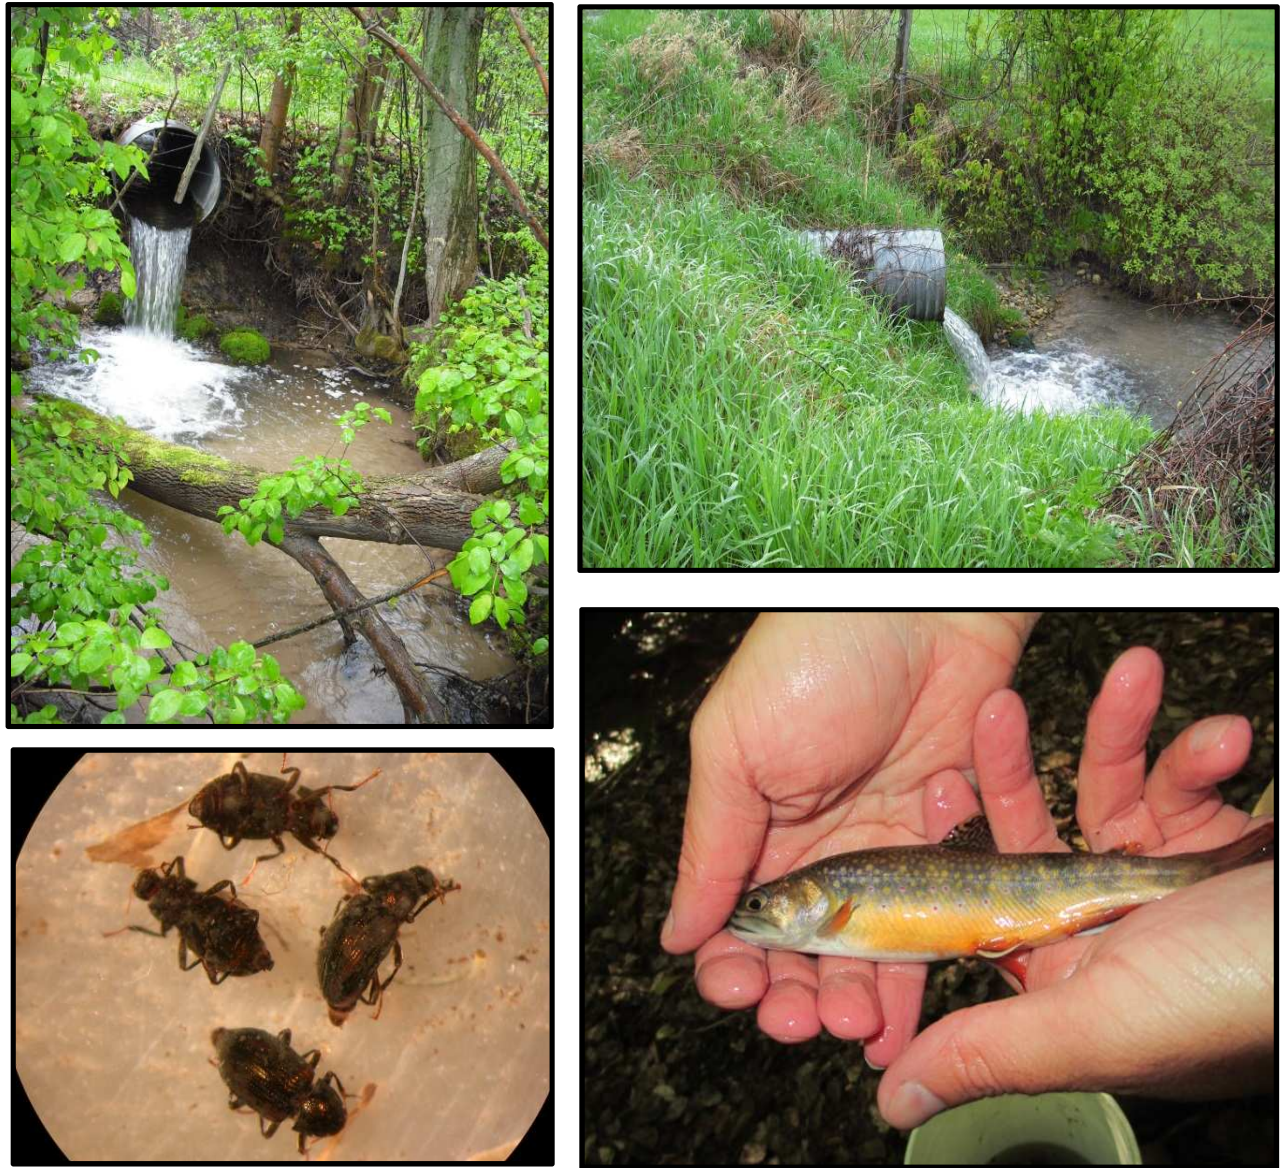
Figure 1. Ware Creek (upper left) and Hull Creek (upper right).

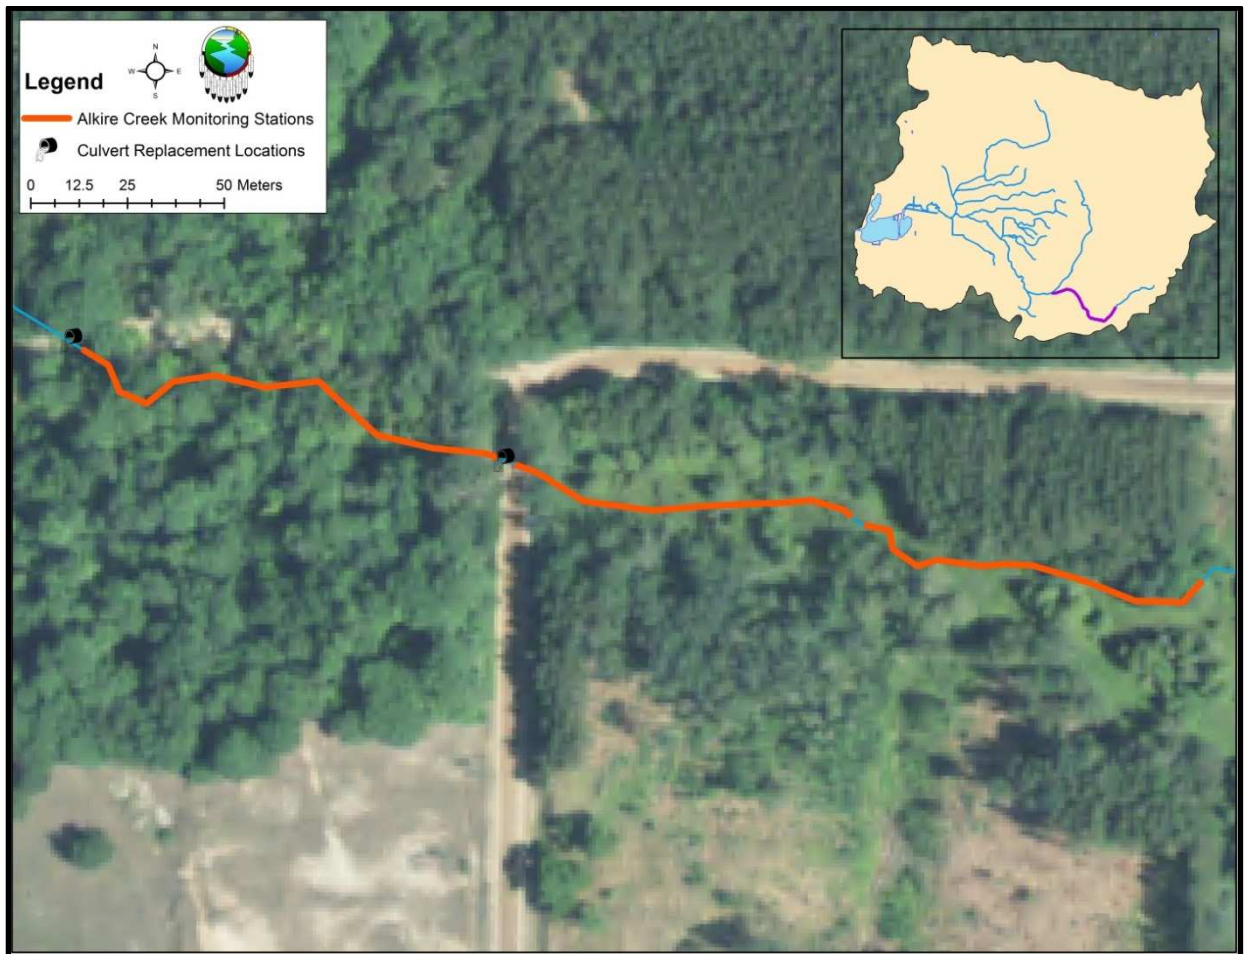
Figure 2. Alkire Creek Site Map.

Alkire Creek is a first order stream located approximately 2.6 km upstream of Bowens Creek (Figure 2). Alkire Creek watershed borders the northern edge of Bear Lake watershed, and extends north with a total catchment area of 19.3 km<sup>2</sup>. Alkire Creek's watershed is dominated by forest (32.7%), grassland (29.2%) and cultivated crops (29.0%). Three 100 m sampling stations were established in the upper portion of Alkire Creek. Station 1 was located just upstream of the replaced culvert at Alkire Rd., Station 2 was located just upstream of the replaced culvert at Myers Rd., and Station 3 was located approximately 10-m upstream from Station 2. Station 1 is

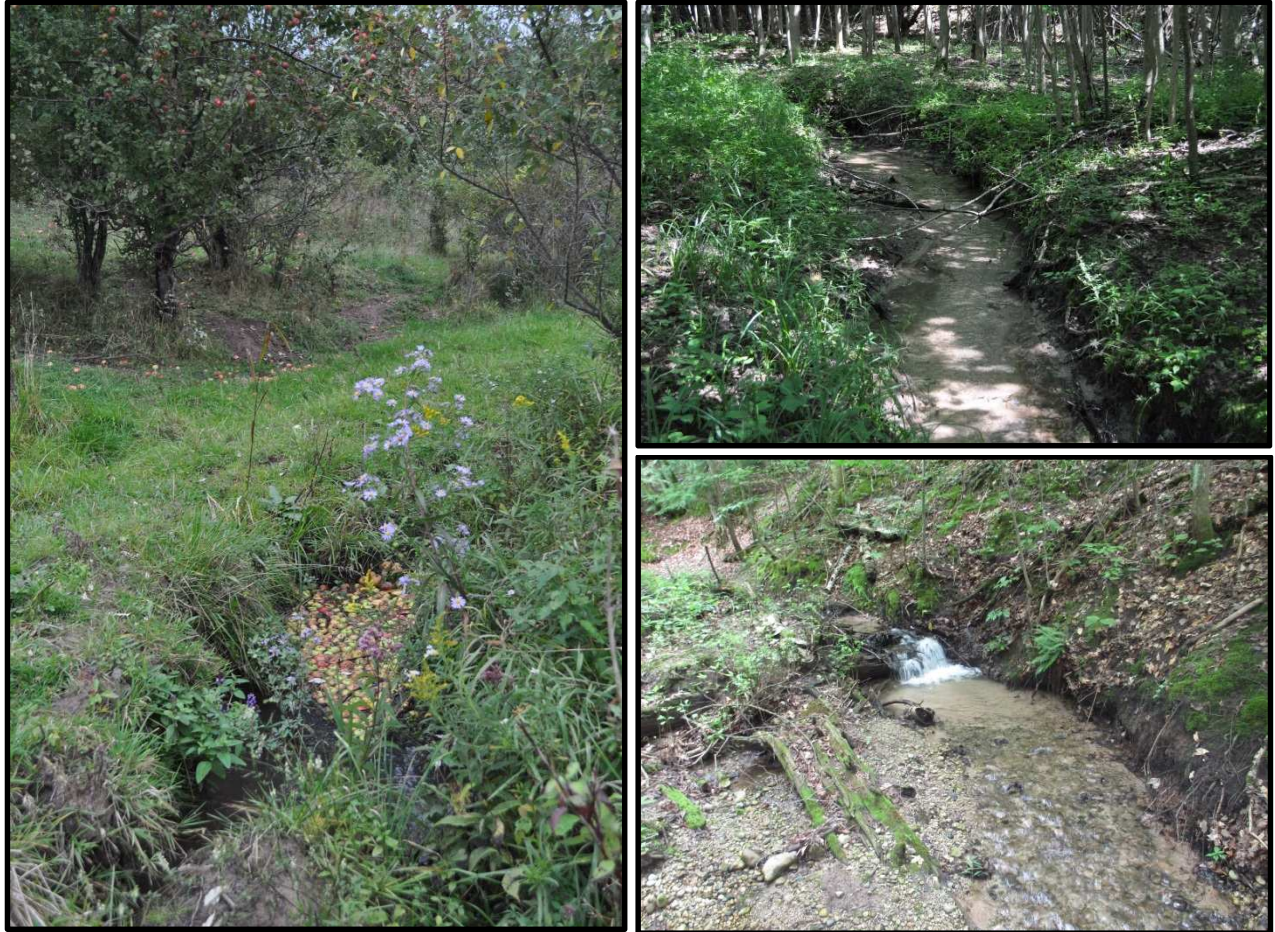
In Stations 1 and 2, the stream flows through pasture land shaded along the banks by grasses and shrubs. Station 3 is heavily shaded by abandoned orchard land providing a unique stream cover (Figure 5). Riparian vegetation transitions to mixed deciduous forest in Stations 4 and 5.

Figure 5. Hull Creek - Station 2 (left), 3 (upper right), and 4 (lower right).

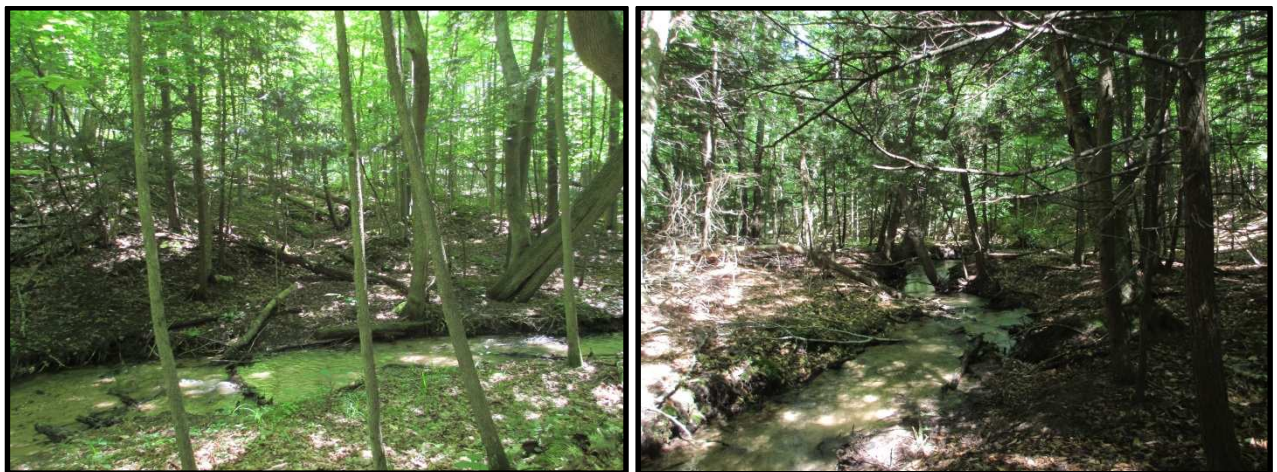
Figure 7. Ware Creek - Station 2 (left) and 3 (right).

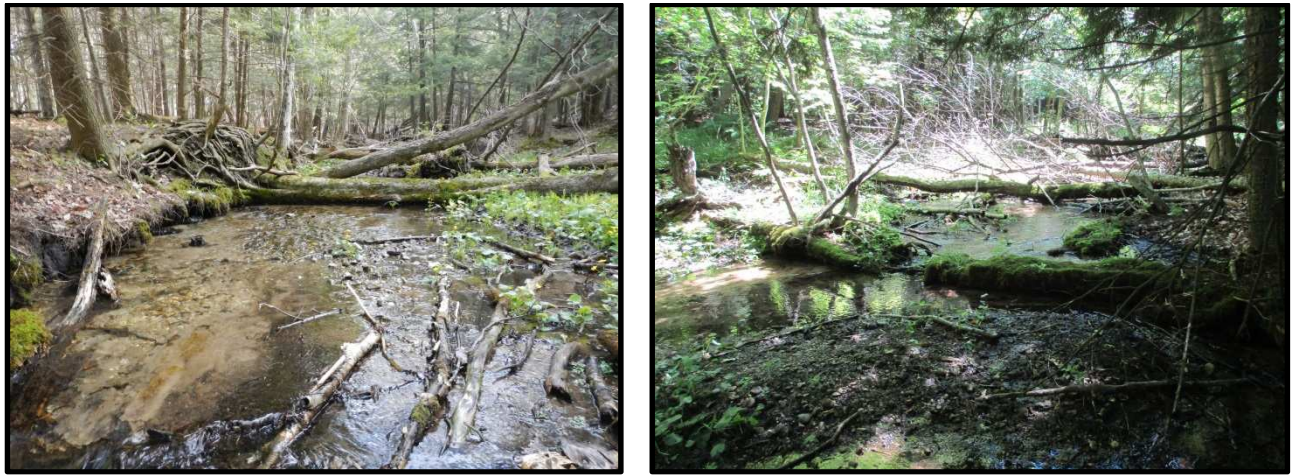
Figure 9. Toohey Creek - Station 2 (left) and 3 (right).

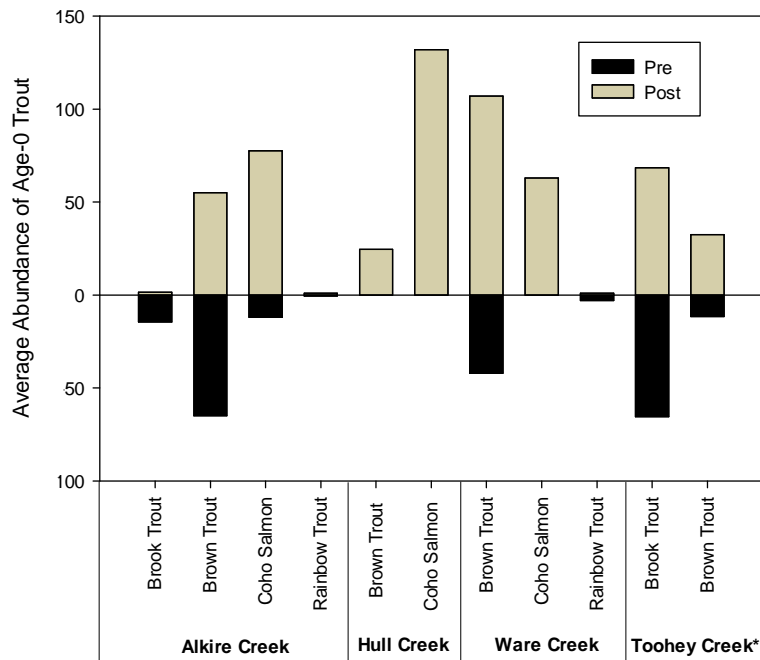
An overall increase in age-0 trout and salmon was observed in all streams (with the exception of the control site) following restoration (Figure 15). Abundances of age-0 coho salmon were notably higher in each stream post-restoration, with the highest abundance in Hull Creek. Post-restoration abundances of age-0 brown trout were higher in Hull Creek and Ware Creek. Overall increases in age-0 trout and salmon indicate recruitment.

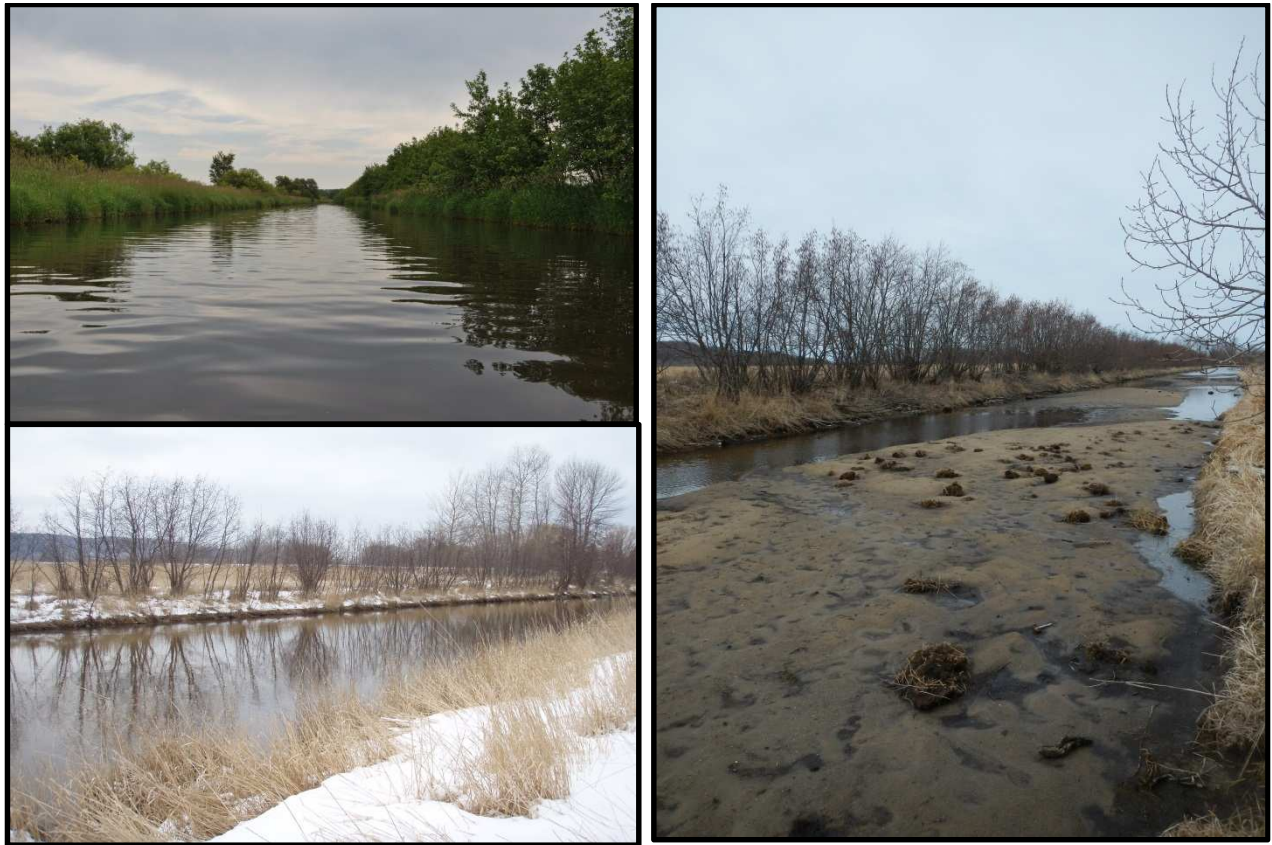
Bowens Creek was channelized along a railroad grade running through Arcadia Marsh and as a result of a host of additional anthropogenic disturbances the stream was nearly completely diverted. The channelized segment ran from just downstream of St. Pierre Rd. approximately 1 km to near its confluence with Arcadia Lake. A 300 m sampling station was established in the lower portion of the channel. The riparian vegetation within this station was predominately grasses and sedges with very little in-stream habitat or riparian cover (Figure 17). Sampling was conducted pre-restoration only. Once the stream was re-routed into the historical channel, the channelized segment filled in and no additional aquatic sampling was performed (Figure 17, right image).

Figure 17. Bowens Creek Channelized Segment – Pre (left) and Post Restoration (right).

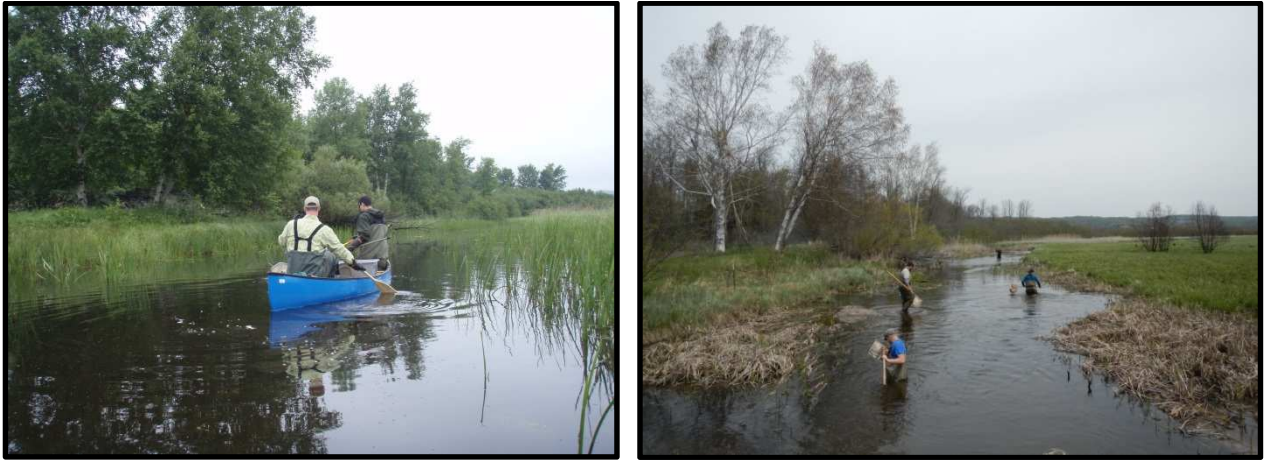
Prior to restoration, the channelized segment bi-passed approximately 1.7 km of the natural stream channel. The lower sampling station in Bowens Creek's historical channel was located just upstream of where the channelized segment re-connected with the natural stream channel (Figure 16 above). Station length was 215 m, and riparian vegetation was predominately cattails, grasses and rushes (Figure 18).

Figure 18. Bowens Creek Historical Channel Lower – Pre (left) and Post Restoration (right).

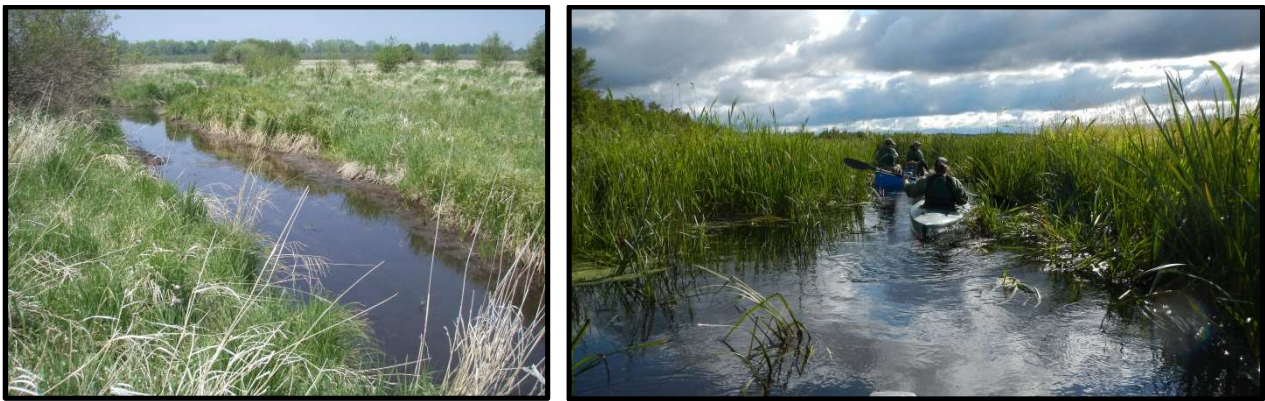
The middle sampling station in Bowens Creek's historical channel was located just upstream of the lower station (Figure 16 above). This station had a relatively unconfined stream channel with sections that were too shallow to kayak (Figure 19). Station length was 215 m and riparian vegetation was predominately cattails and grasses.

Figure 19. Bowens Creek Historical Channel Middle – Pre (left) and Post Restoration (right).

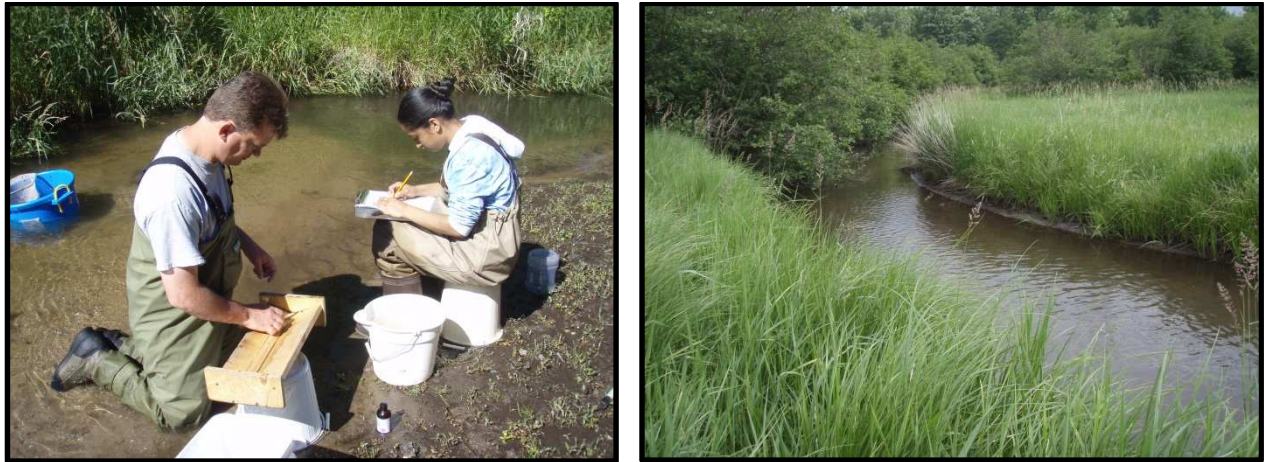
The upper sampling station in Bowens Creek's historical channel was located upstream of the middle station and just downstream of the diversion (Figure 16 above). The upper sampling station was 200 m in length and riparian vegetation was alders, cattails and grasses. In-stream habitat was characterized by undercut banks and overhanging vegetation (Figure 20).

Figure 20. Bowens Creek Historical Channel Upper – Pre (left) and Post Restoration (right).

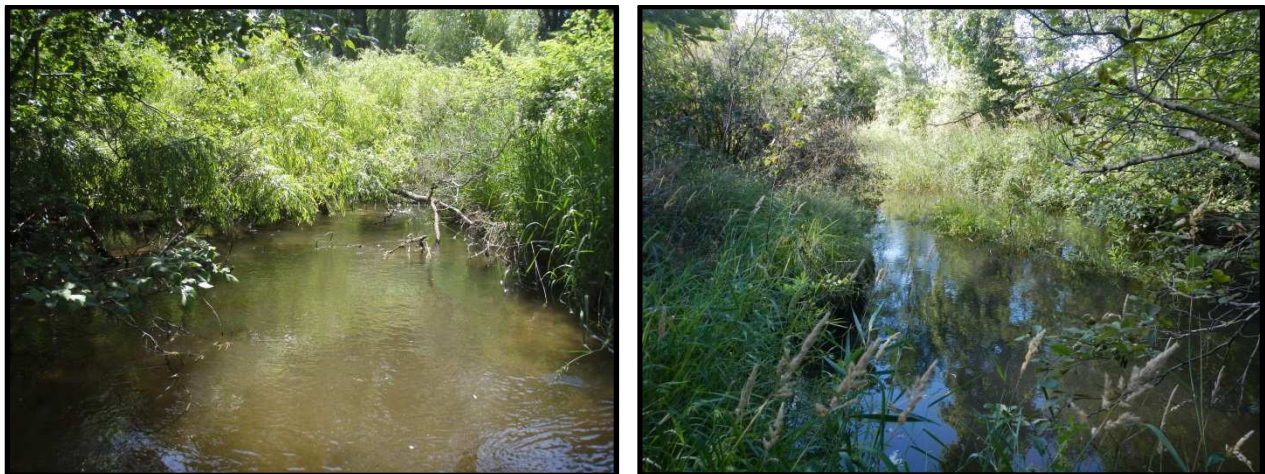
St. Pierre Rd. sampling station was located downstream of St Pierre Rd. and ending at the diversion (Figure 16 above). This station was used as a control for the lower watershed because it was located upstream of the diversion. The station was 200 m in length and riparian vegetation was predominately mixed deciduous, alders, cattails and grasses. In-stream habitat was characterized by large bends, undercut banks, and overhanging vegetation (Figure 21).

Figure 21. Bowens Creek downstream of St. Pierre Rd. – Pre (left) and Post Restoration (right).

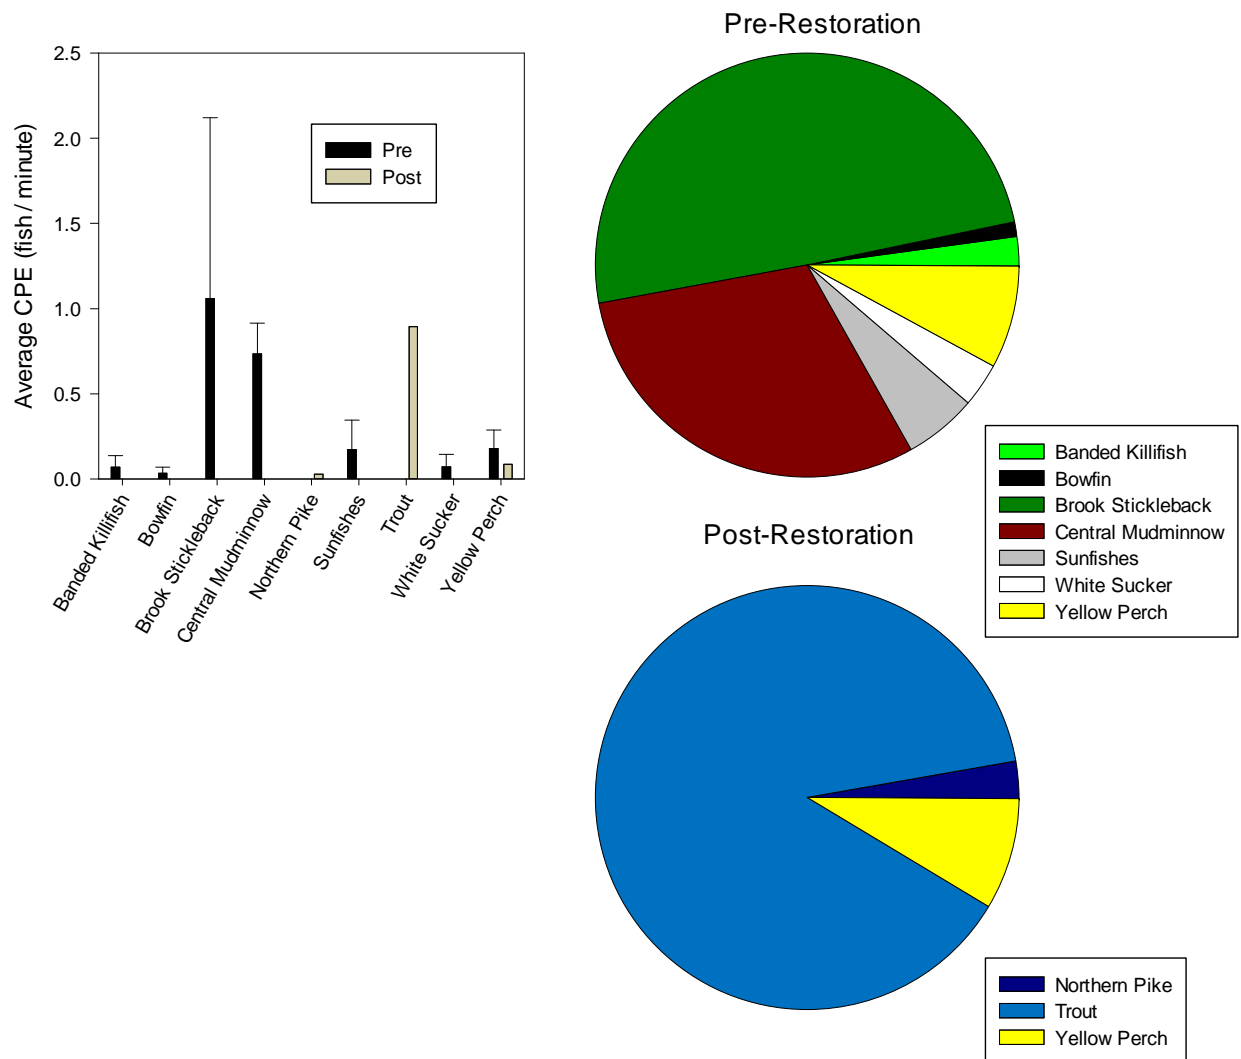
Prior to restoration, the fish community included brook stickleback (*Culaea inconstans*), central mudminnow (*Umbra limi*), yellow perch (*Perca flavescens*) and white sucker (*Catostomus commersonii*). Post restoration, the fish community shifted to predominately trout (64.5% rainbow trout, 35.5% brown trout), yellow perch, and northern pike (*Esox Lucius*) (Figure 23). Yellow perch was the only fish species that was observed both before and after restoration. Overall CPE was lower following restoration, with trout CPE's averaging less than 0.9 fish per minute.

Figure 23. Bowens Creek – Lower Fish Community
